BEFORE AND AFTER EXAMPLE PICTURES OF MIRE RESTORATION SITES

Example 1. BROADMEAD

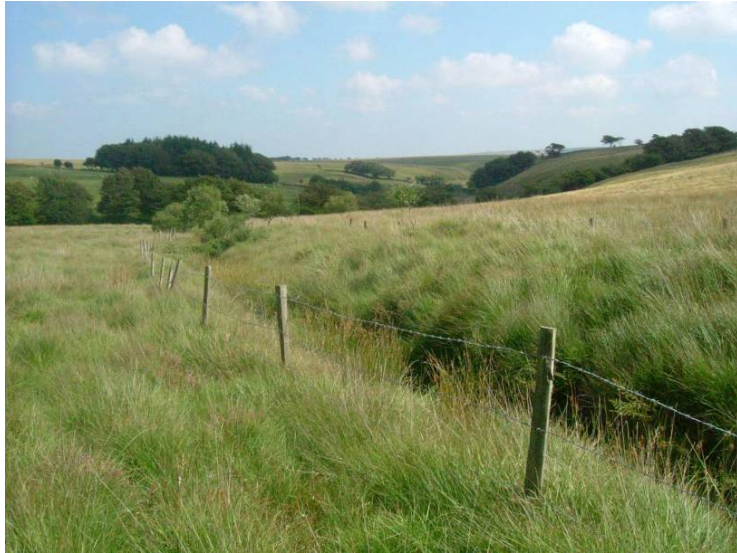
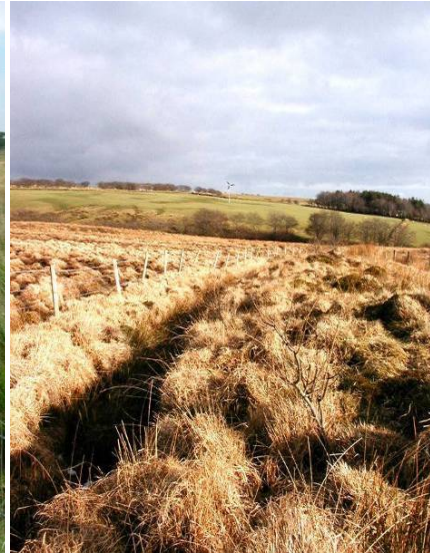
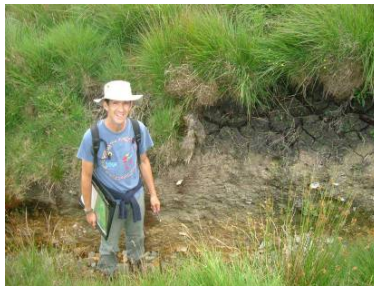
BEFORE restoration – summer 2006

In the ditch before restoration

The ditch was fenced, over 3m deep, eroding and cracking, drying out the peat with large chunks dropping of the side in to the ditch. The restoration contractor put in 16 wooden blocks, backed up with peat sourced from borrow pits. The ditch was filled with locally cut moorland bales and these were covered over with ditch spoil from the bank on the side of the ditch.

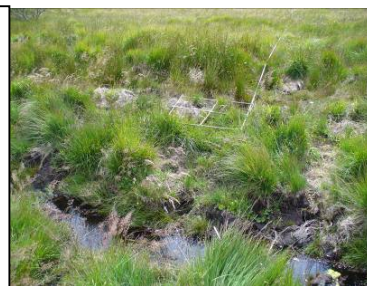
Ditch after restoration

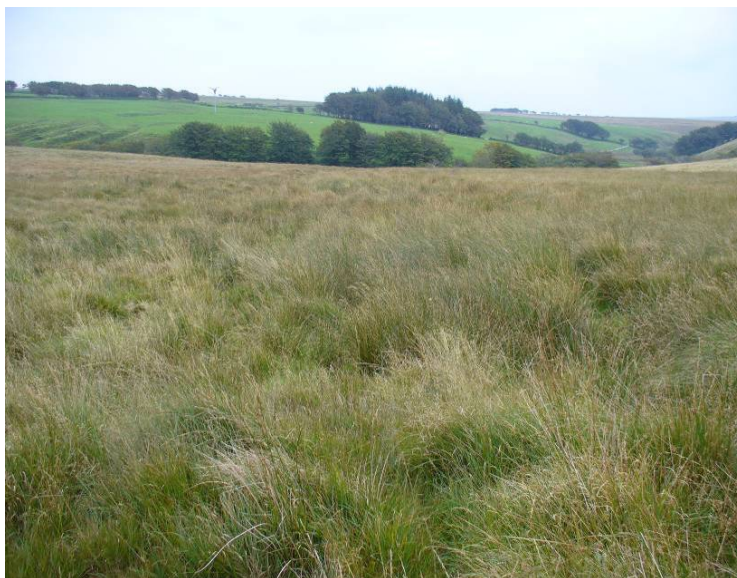
POST Restoration summer 2010

The ditch, fence and scrub encroachment are now gone (all removed by the contractor).

Replaced by some new pools in the small peat borrow pits along the line of the ditch (being enjoyed by an educational group from Pinkery outdoor centre)

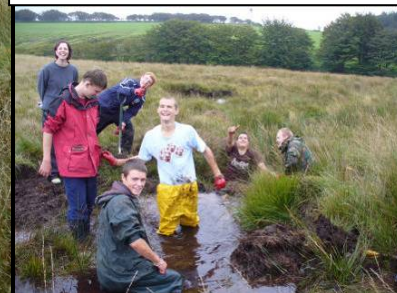
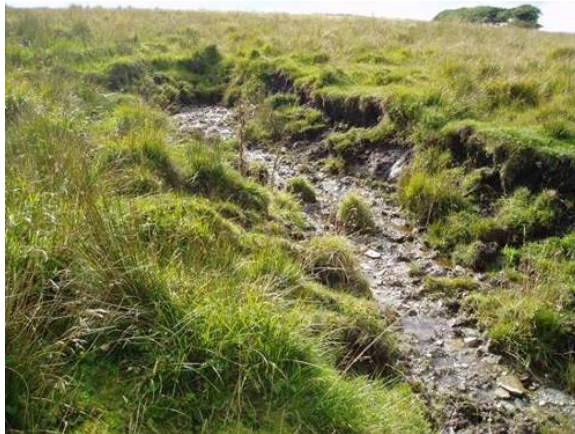
BEFORE

Ditch before blocking (left), the site was eroding back from the spring head with lots mobile peat and shillet in the gully bottom

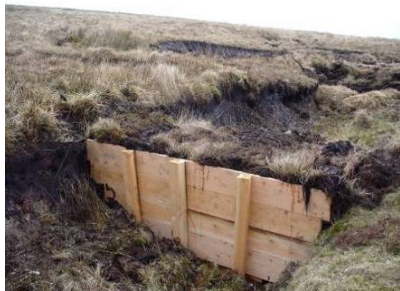
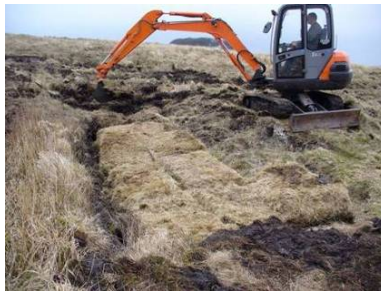
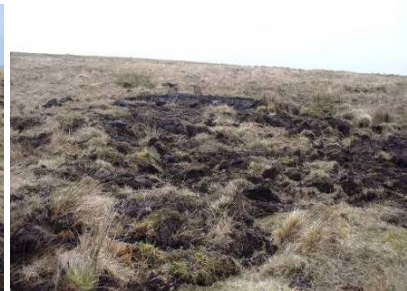
DURING

The restoration works (below) wooden blocks were built and backfilled with peat, bales were then put into the ditch and finally the whole lot covered over with ditch spoil to complete the job

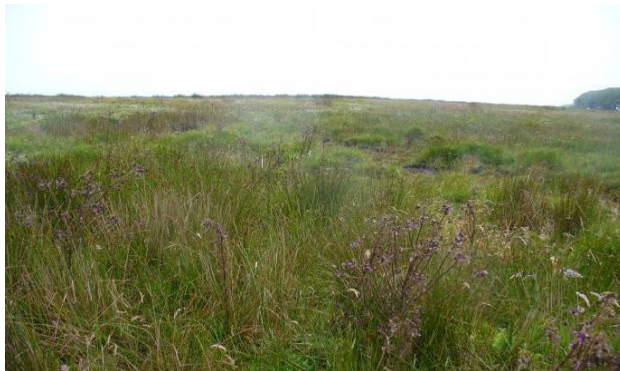
AFTER

View of filled in ditch in August 2010 (left). The small areas of bare peat visible are the partially vegetated peat borrow pits, from which peat was derived to seal the wooden dams

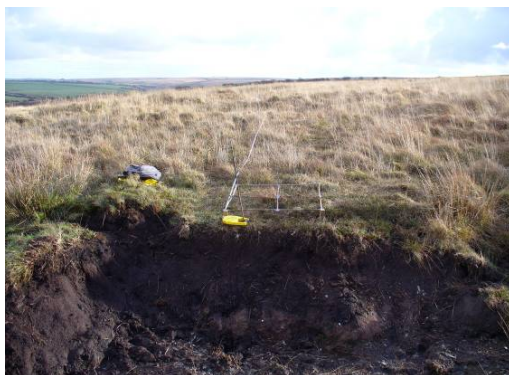
View of the vegetation monitoring transect in 2006 (bottom left) and 2010 (bottom right). Note and compare the position of the tape which was relocated to the exact spot marked by wooded pegs - **The ditch is completely gone!**

Before - bare eroding peat in ditch

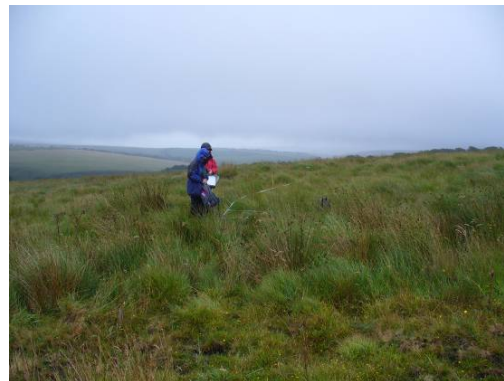
After- no evidence of ditch remains

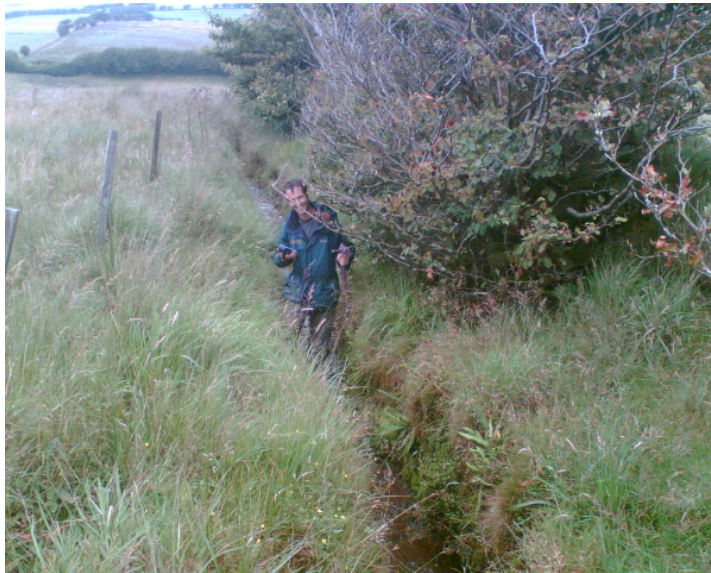
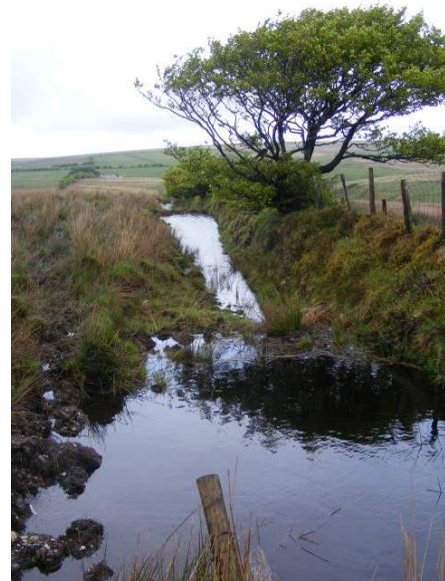
Example 3 Roosthitchen boundary ditch

- i. Boundary Ditch Aug 2008
- ii. Boundary ditch immediately after restoration works

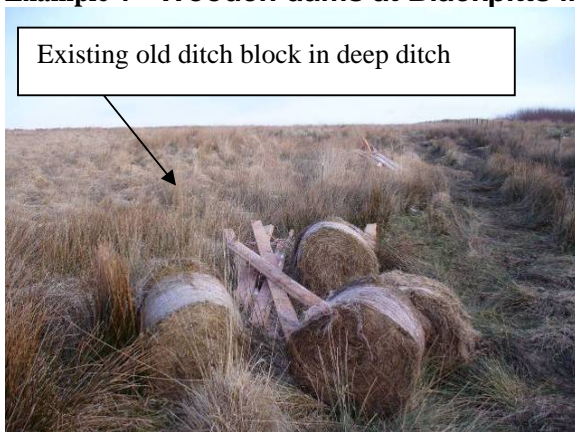
Before (construction materials at the ready)

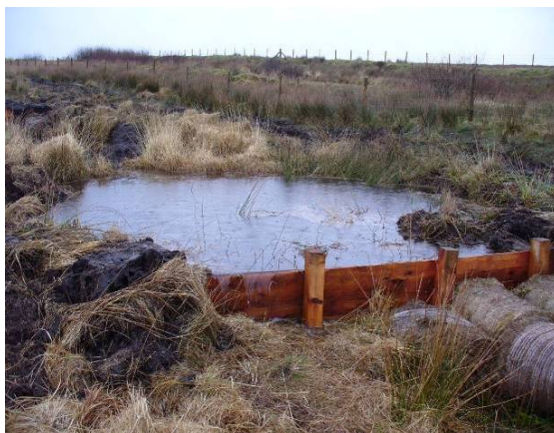
Immediately after construction of a new block

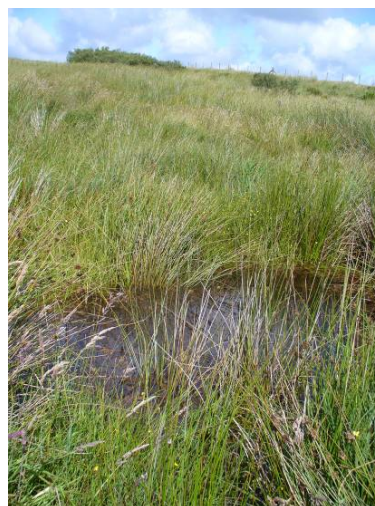
August 2010 –block hardly visible

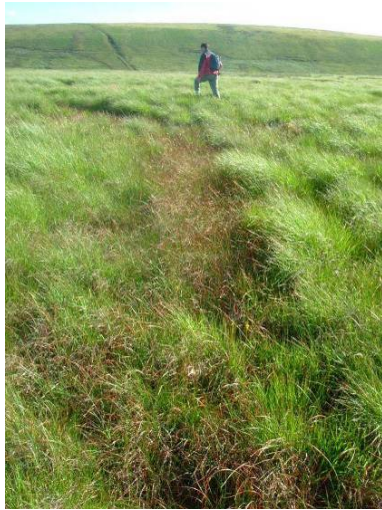
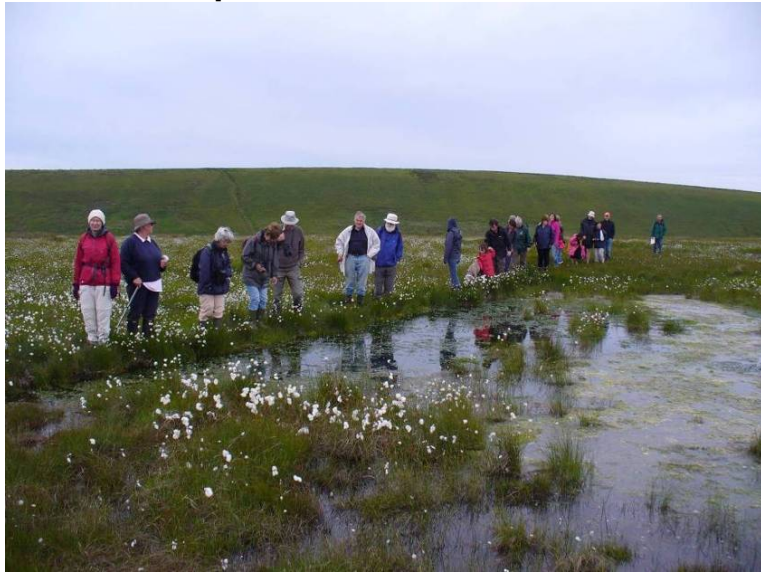
Example 5. New peat Dams at Blackpitts

Dry peat cuttings in Summer 2006 and 1 year after blocking with peat (photo 2008)

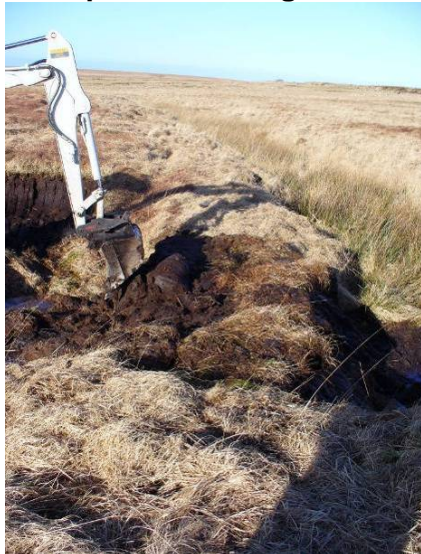
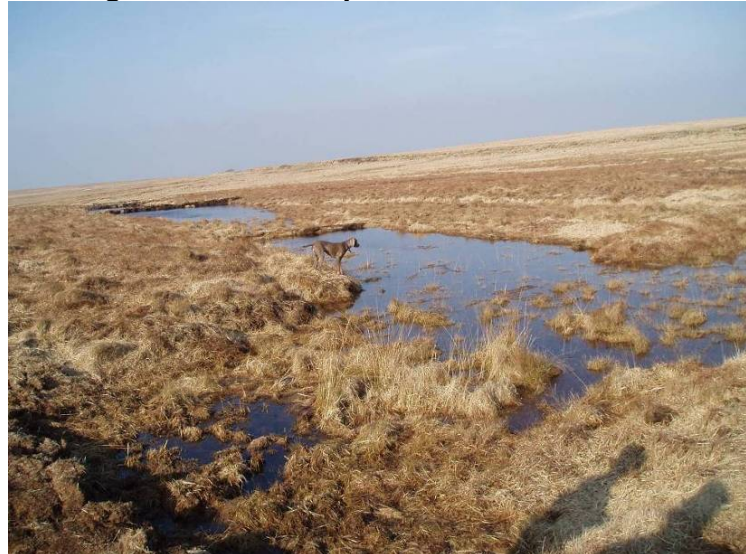
Example 6. Blocking the main drainage ditch at Blackpitts

Just before the ditch was blocked in March 2006 and 1 year later

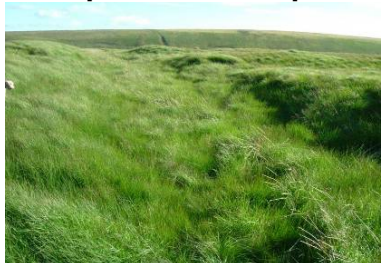
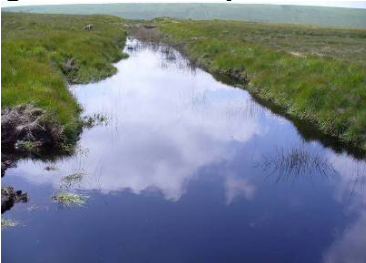
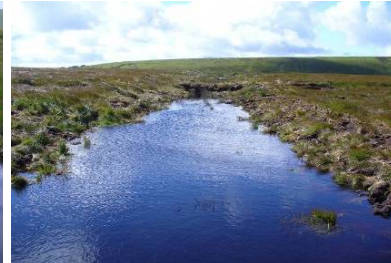
Example 7. Bank re-profiling work at Blackpitts

Main drain before blocking- summer 2006, After blocking (March 07) in summer 2007 and after bank re-profiling in August 2007

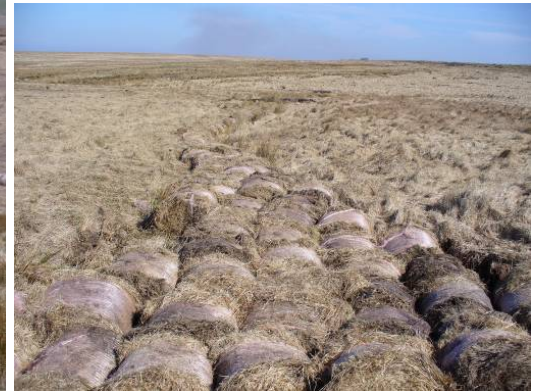
Using bales to block gullies

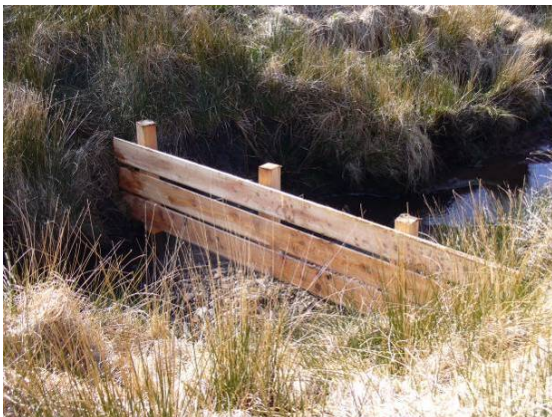
Fence across gully to hold bales

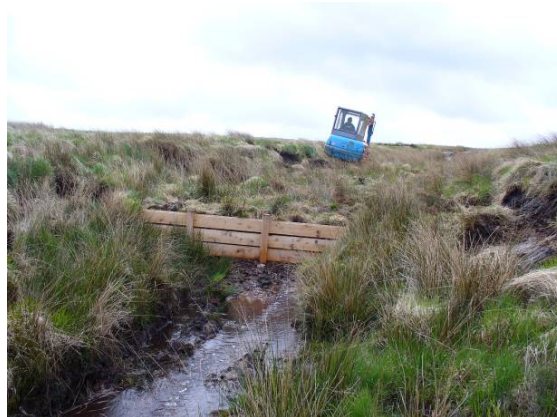
Bales being put in place

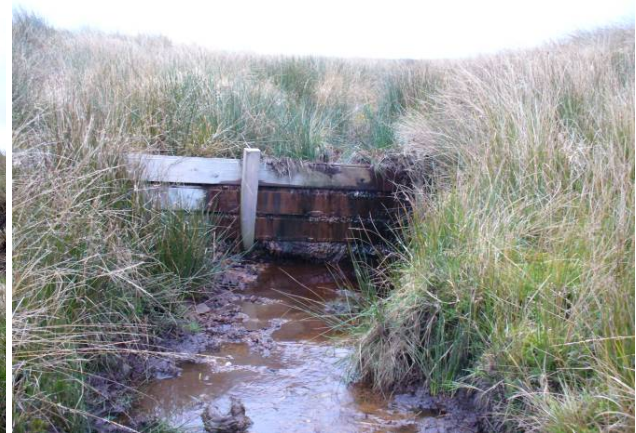
Bale block - 1 year later
