Erosion on Exmoor

Introduction

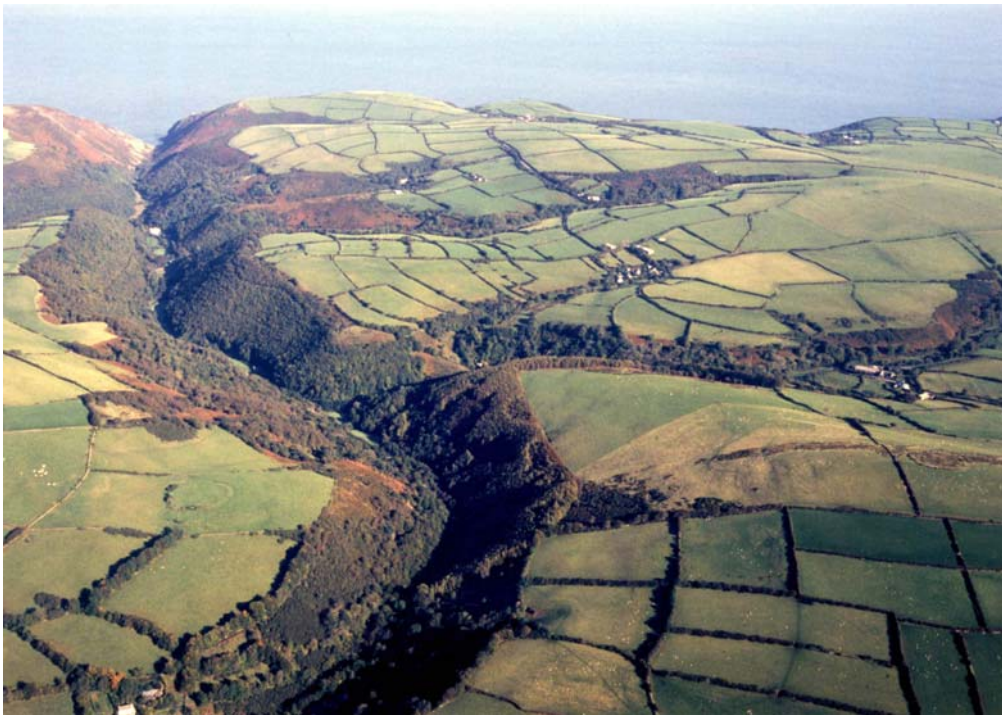
An aerial view of Heddons Mouth showing the steep combs typical of Exmoor © ENPA

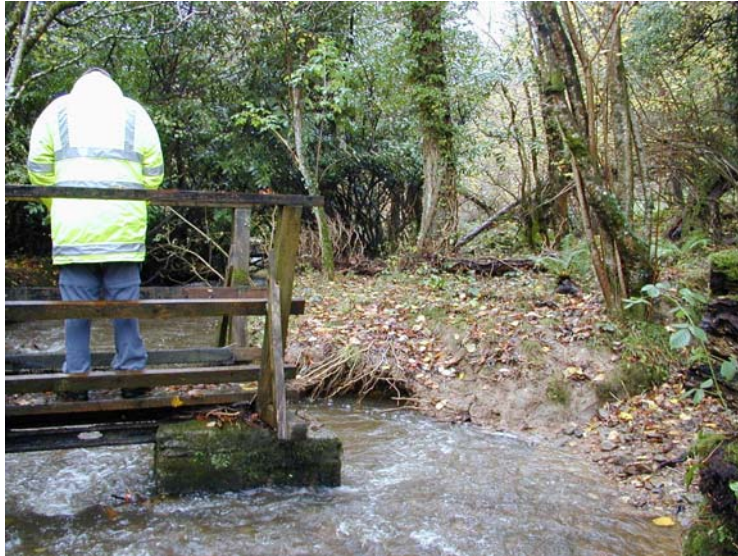
Streams and rivers can rapidly change course © ENPA

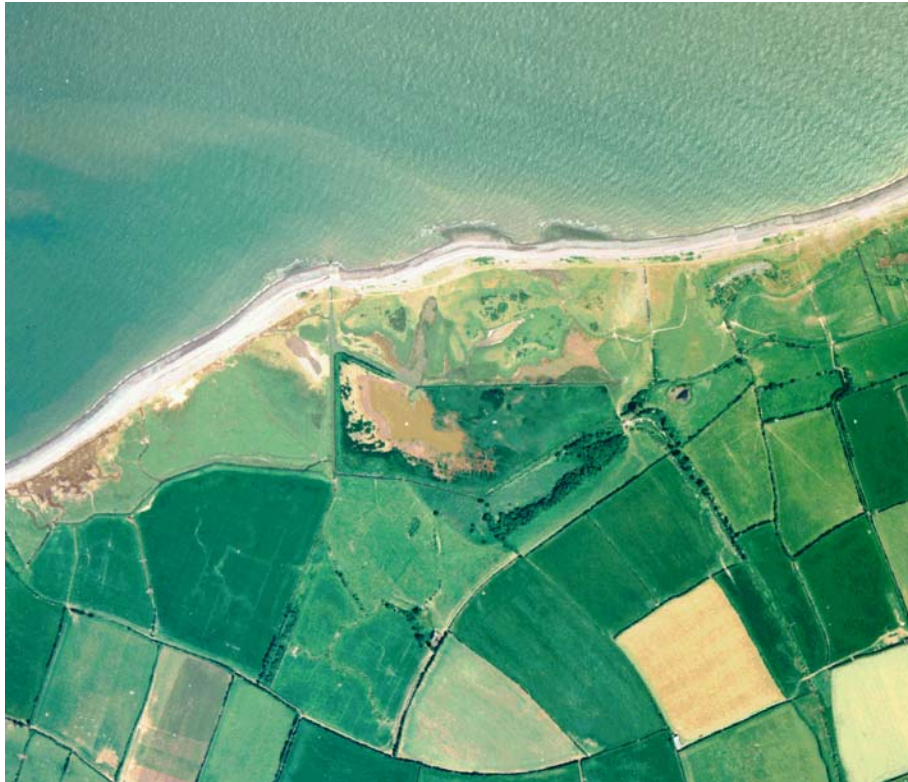
Aerial view of Porlock Shingle Ridge 1995 (pre breach) © ENPA

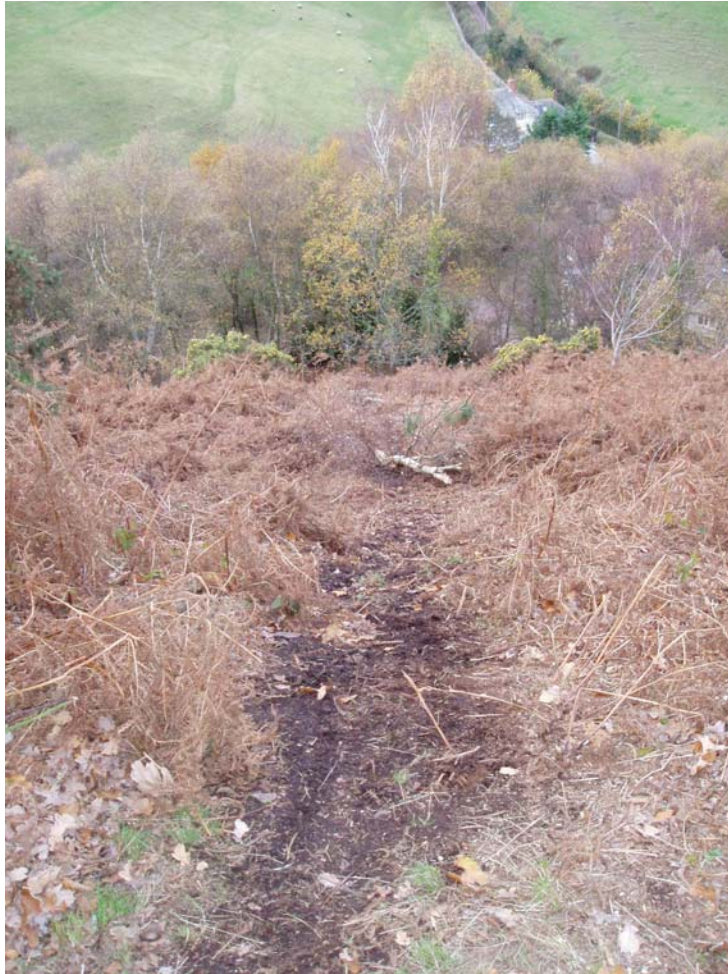
Before – A scar such as this can quickly develop into a serious erosion problem. © ENPA
